# SOUTH-EAST CORNER OF KING STREET WEST AND BATHURST STREET

## HERITAGE IMPACT ASSESSMENT

647 & 663 King Street West and 60 Stewart Street, Toronto, Ontario

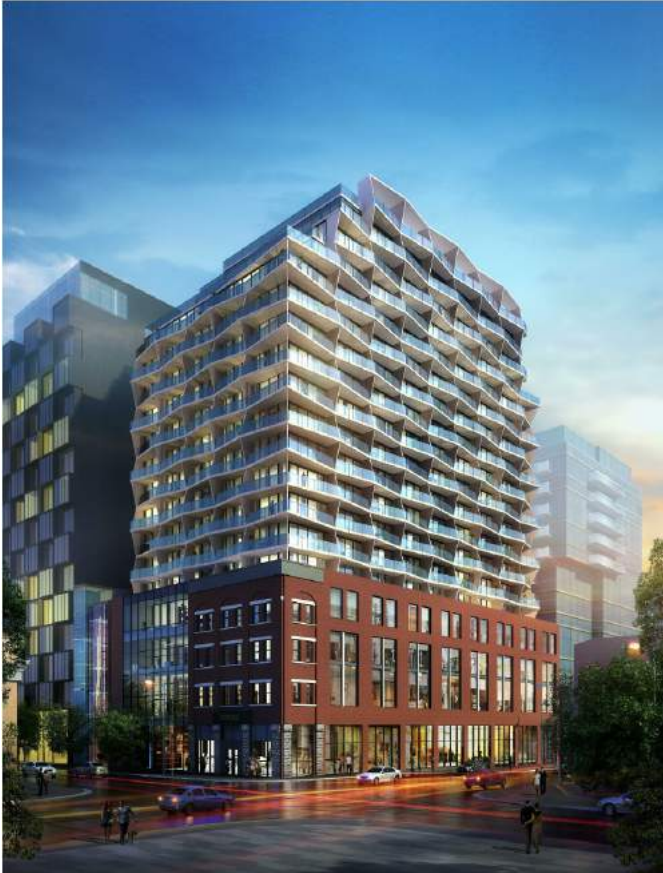
above | Proposed building (DSAI, 2016).

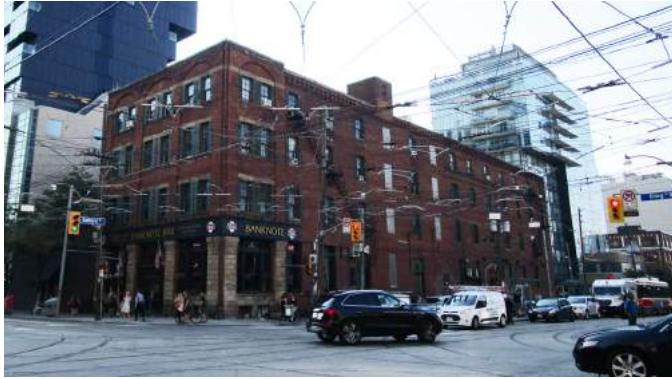
As evaluated by Ontario Reg. 9/06 this property is a candidate for designation under Part IV of the Ontario Heritage Act.

The architectural details and features of the principal façade and first bay of the west façade are in good condition and have not been altered. Architectural features along the remainder of the west façade and the south façade have been altered to accommodate various uses, owners and tenants of the building.

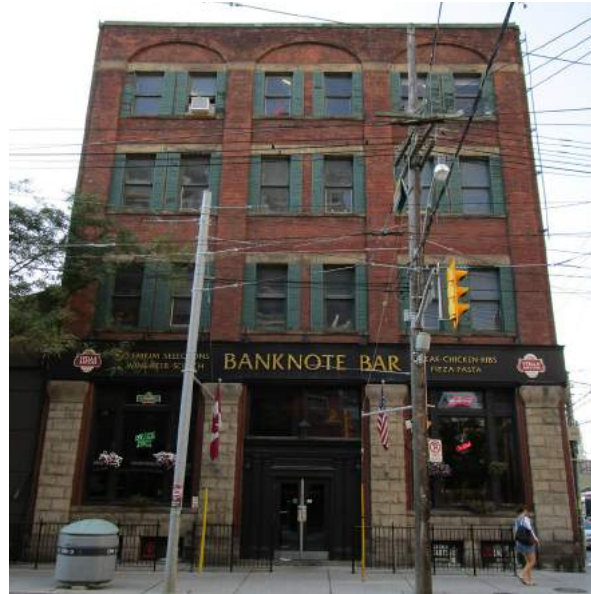
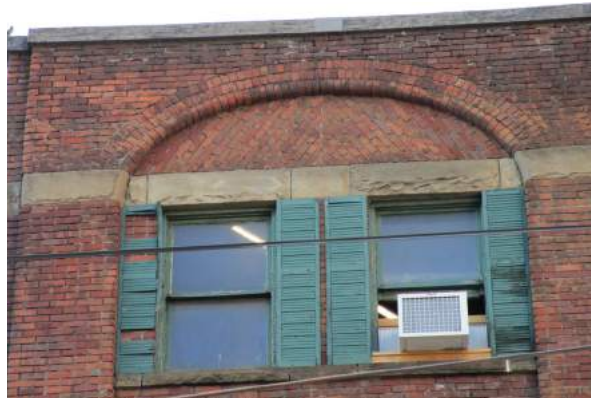
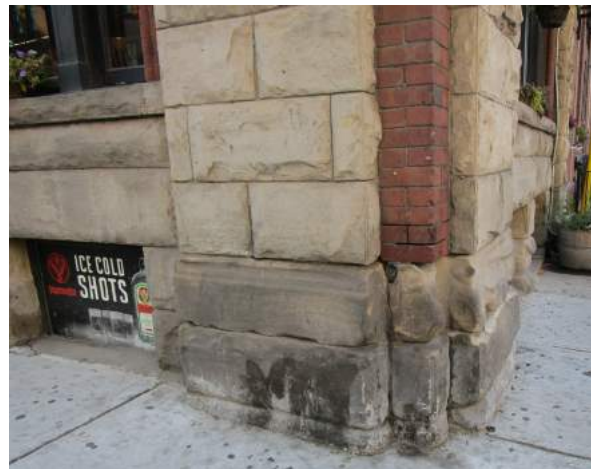
The north elevation stone base is in poor to fair condition with areas of mortar and material loss, environmental staining and efflorescence at the base.

The north elevation brick façade is in poor condition with areas of mortar loss, environmental staining, spalled, missing and broken bricks, attached fasteners and holes.

The wood window shutters are in poor to defective condition with material loss, warped wood, paint loss and water damage. The masonry window lintels and sills appear to be in fair condition with environmental staining and mortar loss.

The windows on the 2nd to 4th floor appear to be original and are in poor condition with paint and material loss and broken glass panes. The parapet flashing is in poor condition.

Top to bottom: north elevation (general); decorative brickwork, window and parapet (typical); stone base.

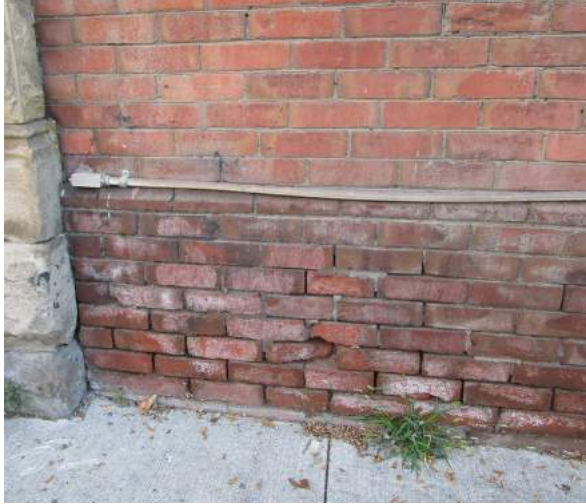
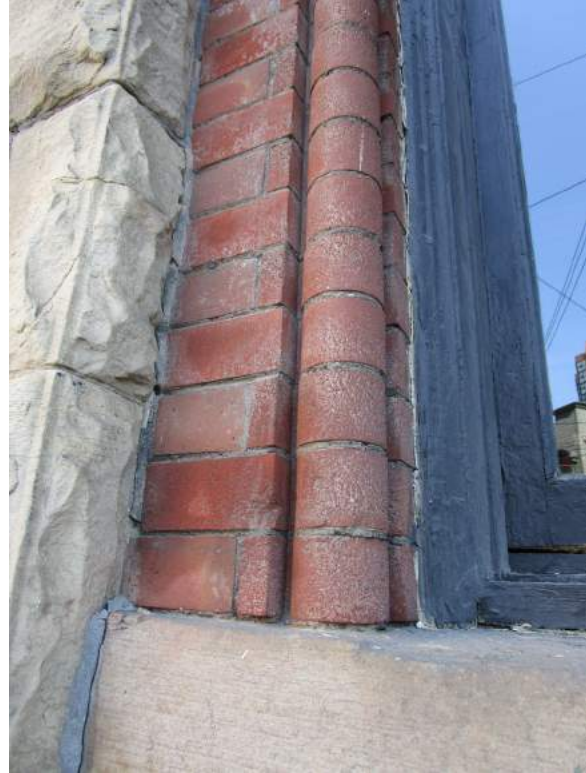
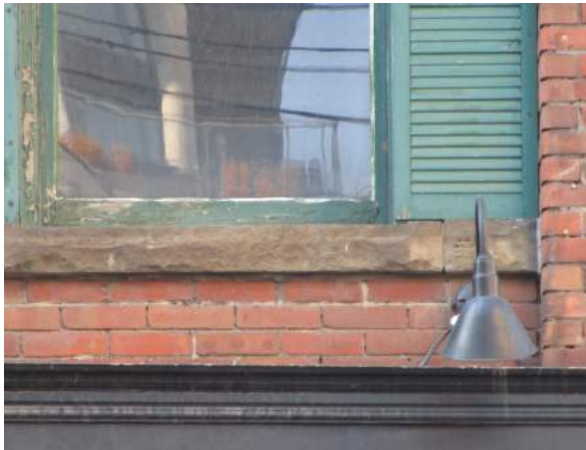
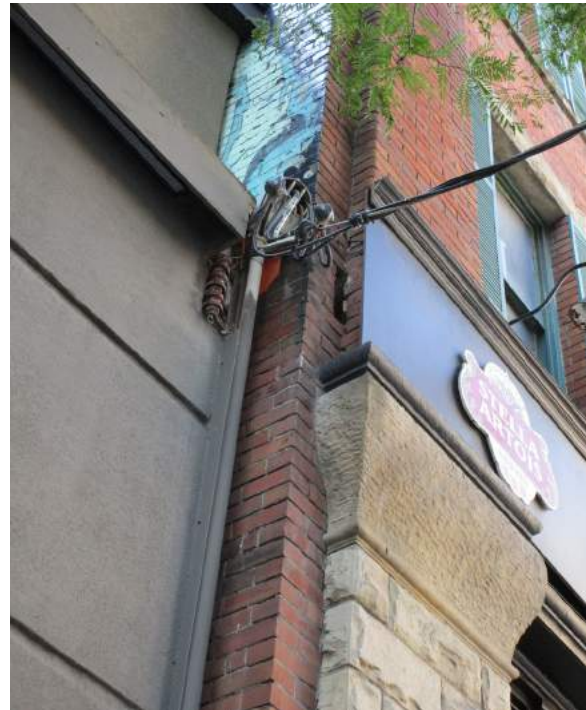
Clockwise from top left: deteriorated masonry; decorative brickwork; metal fasteners and contemporary painted signage (detail); original sill and windows (detail).

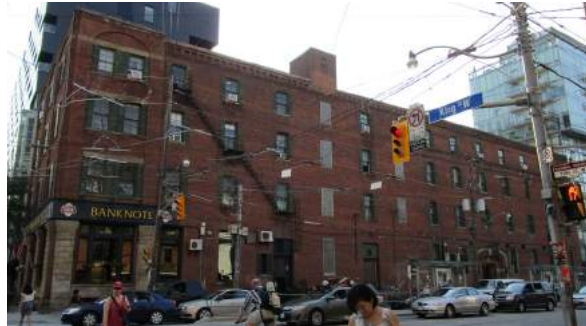
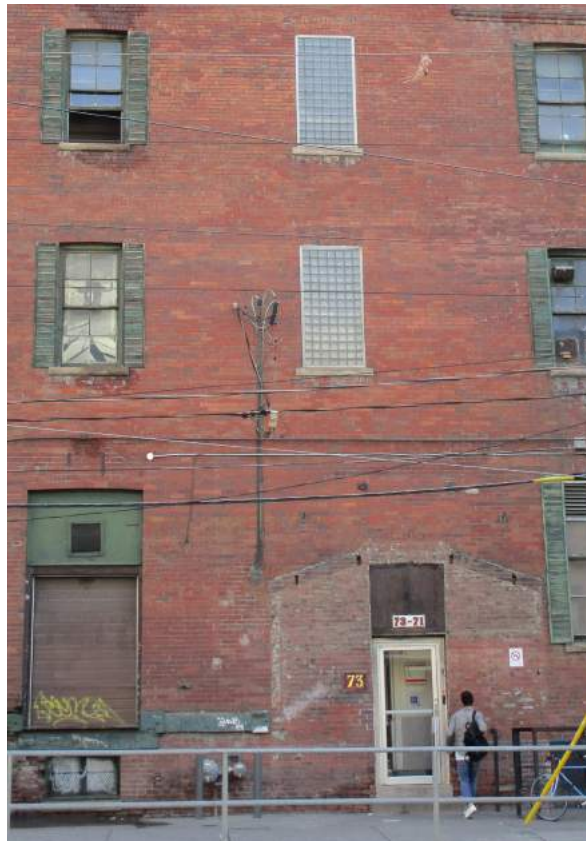
The west elevation brick façade is in poor to defective condition with areas of mortar loss, efflorescence, water damage, environmental and biological staining, spalled, missing and broken bricks, attached fasteners and holes and step cracking in the brickwork.

Seven of the existing masonry openings have been modified with glass blocked infill. The majority of the window sashes on the 2nd to 4th floor appear to be original and are in poor condition with paint and material loss and broken glass panes. The remaining parapet flashing is in poor condition and the majority of the parapet flashing is missing on elevation. There is bird activity in one of the existing vents.

The wood window shutters are in poor to defective condition with numerous windows missing one or two shutters. An opening at grade appears to be modified with ghosting of a removed entryway and the brick façade in this area is in poor condition with missing, deteriorated and spalled bricks, attached fasteners and holes. The masonry sills on this façade are in fair condition but there is environmental staining beneath the majority of the sills.

The two existing metal exit stairs remain attached to the façade and are in fair condition with the south end stair area vandalized with graffiti (it is unclear whether these stairs are original).

Top to bottom: west elevation (general); altered openings (typical).

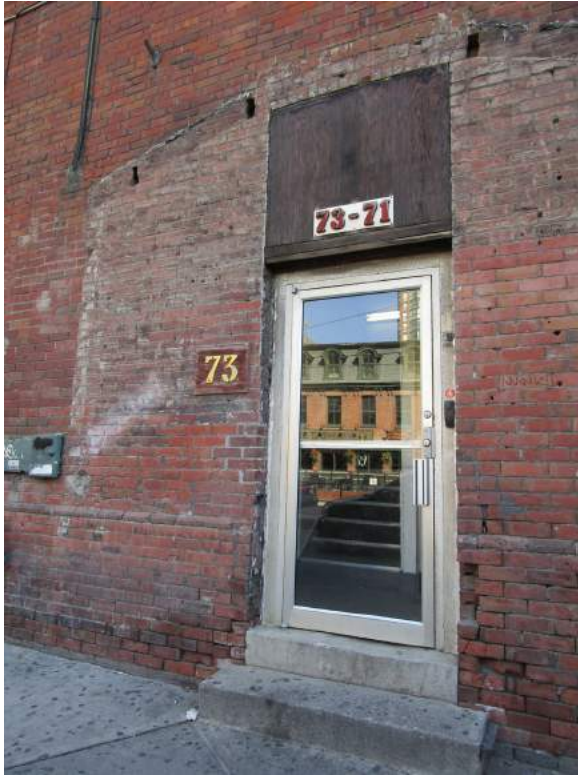
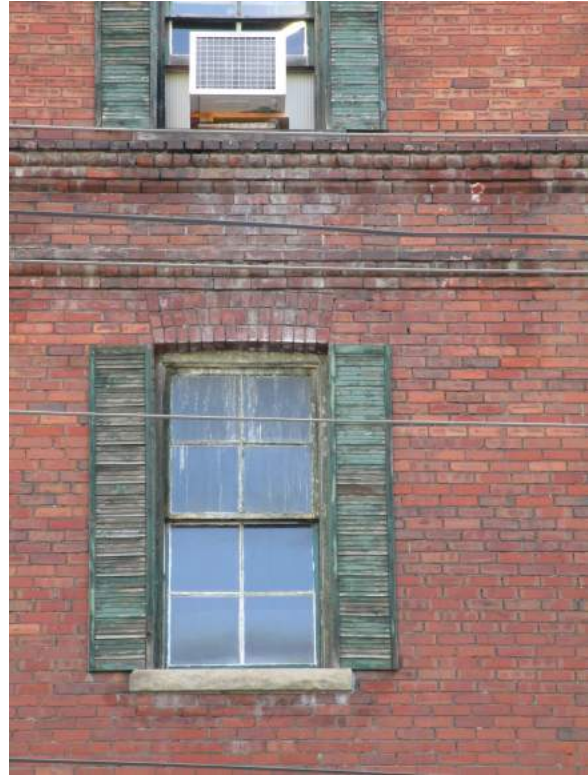
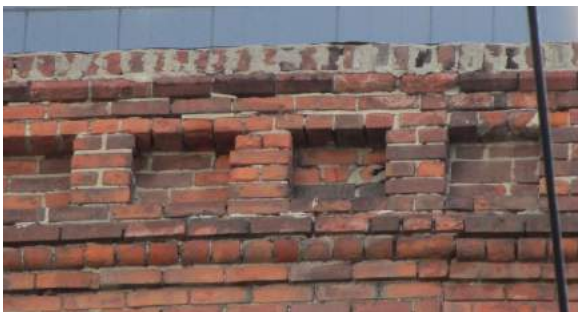
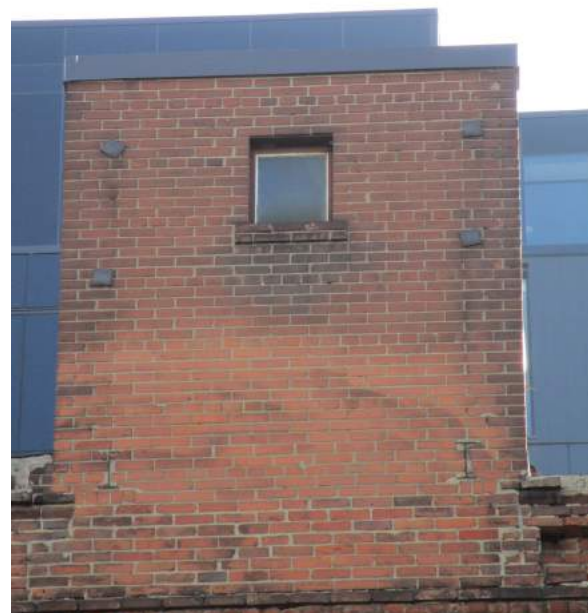
Clockwise from top left: removed entryway and modified door; windows, masonry sills and brick detailing (typical; southern bays); roof access/penthouse addition; parapet (typical).

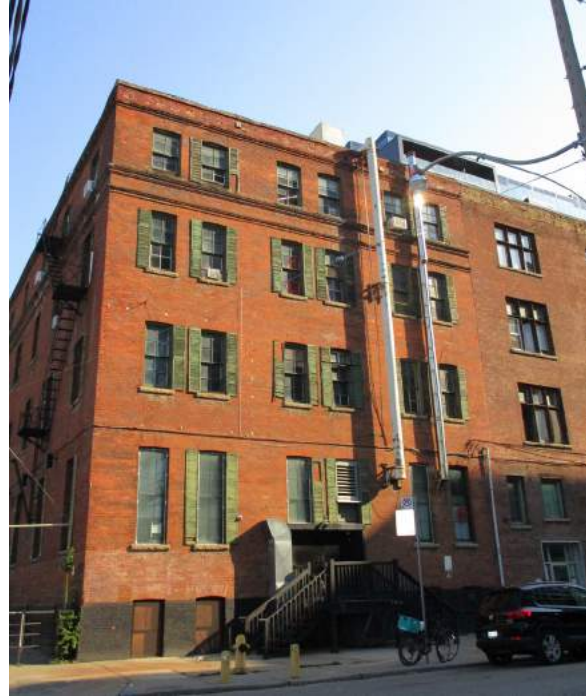
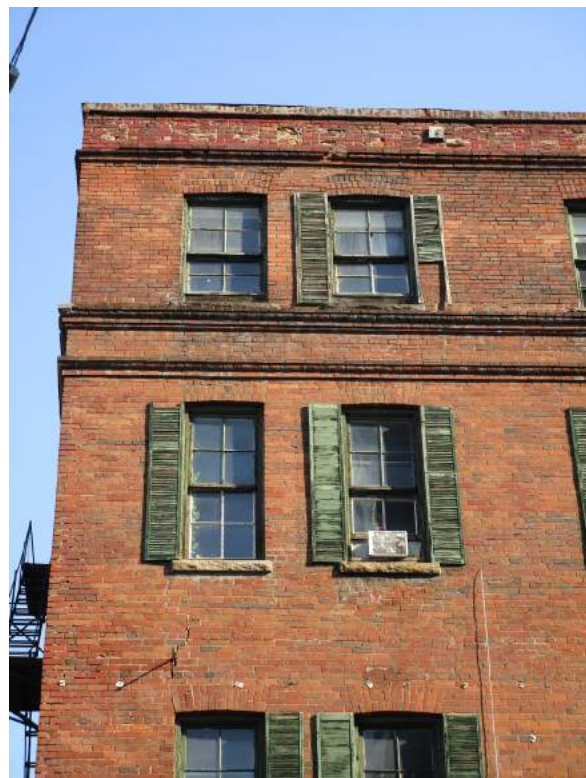
The south elevation brick façade is in defective condition with areas of mortar loss, efflorescence, water damage, environmental and biological staining, spalled, missing, deteriorated and broken bricks, attached fasteners and holes. Major step cracking is evident in the brickwork at two bays from the parapet to grade. The parapet bricks are deteriorated and have efflorescence and the parapet flashing is missing. The masonry sills on this façade are in fair condition but there is environmental staining beneath the majority of the sills.

The wood window shutters are in poor to defective condition with numerous windows missing one or two shutters. The windows on the 2nd to 4th floor appear to be original and are in poor condition with paint and material loss and broken glass panes. Two existing 2nd floor window openings have been modified to accommodate a new opening at grade.

Top to bottom: south elevation (general); upper storey windows and parapet (typical).

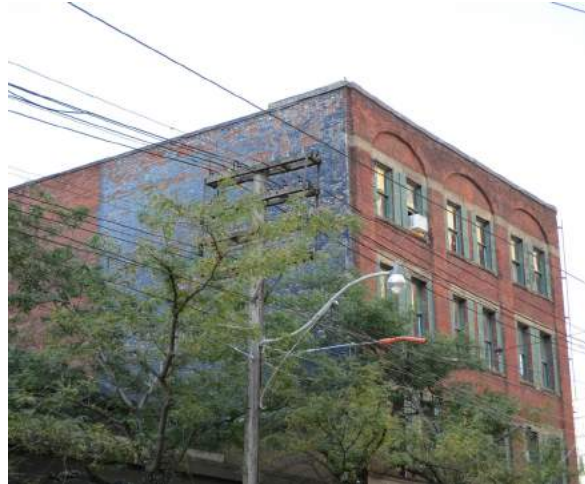
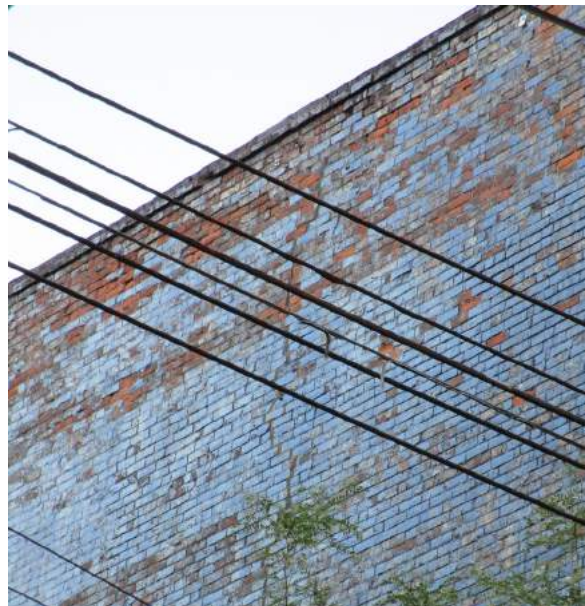
The east elevation brick façade is partially visible from grade. Spalled and missing bricks and mortar loss are evident. The east elevation was historically used for painted signage, which appears to have been painted over.

Top to bottom: east elevation (general); painted masonry.

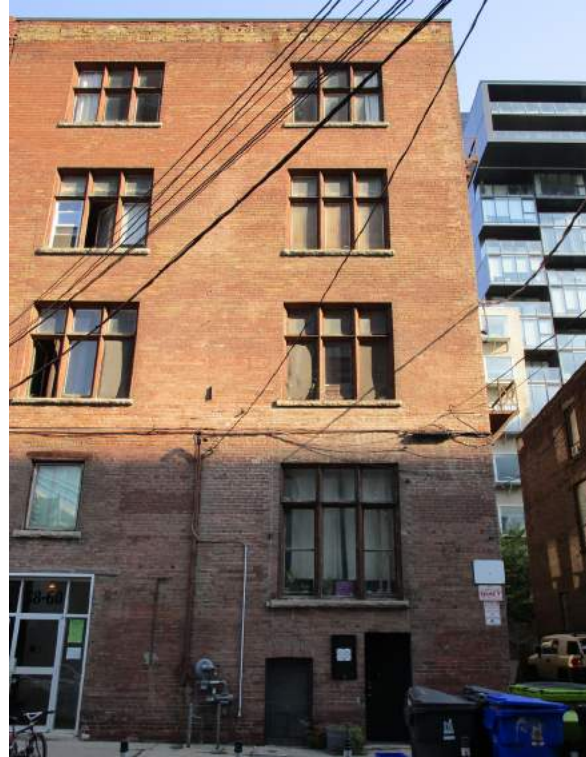
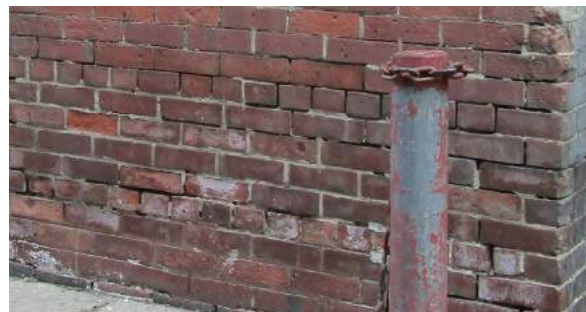
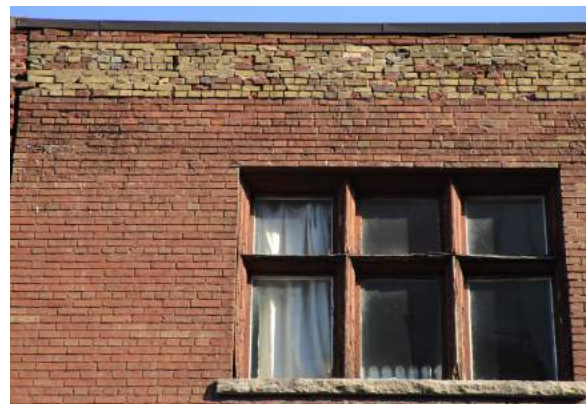
The south elevation parapet bricks are in poor condition with spalled, missing and broken bricks along the entire length of the façade.

Overall, the parapet flashing is in fair condition. The masonry sills are in fair condition. The windows are in poor condition with paint and material loss. The south elevation ground floor to 2nd floor brick façade appears to be sandblasted and the face of the brick eroded.

Top to bottom: south elevation (general), south elevation masonry (typical); parapet and masonry sills).

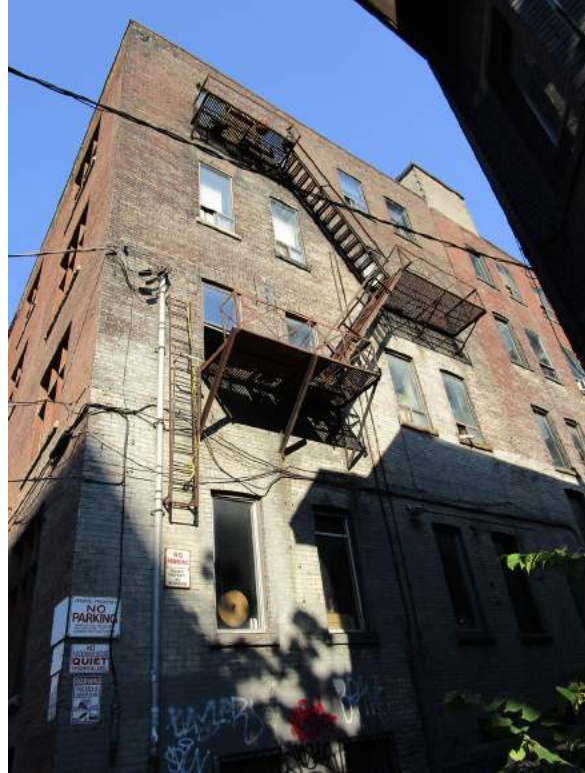
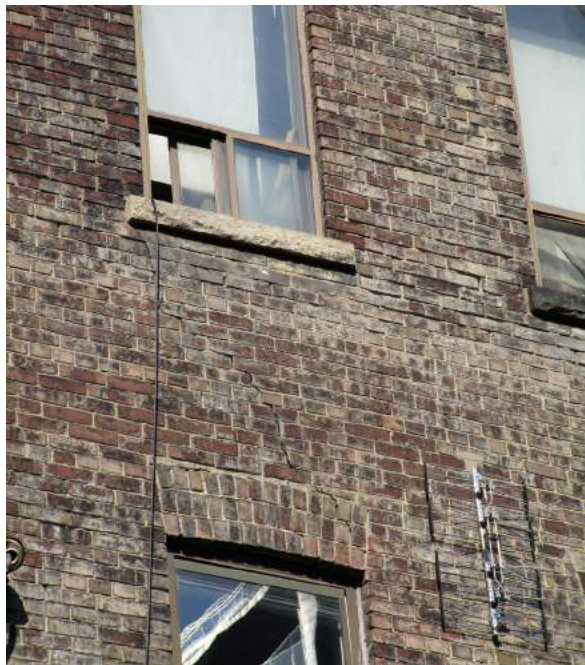
The east elevation brick façade is in poor to defective condition with numerous areas of step cracking in the brickwork, paint and graffiti at grade to the underside of the second floor window sills. There are two existing metal fire escape stairs on the façade and they are in fair condition. An existing loading dock is on this façade with a wooden door in poor condition. Vinyl windows are installed on the east elevation and are in fair to poor condition

The masonry sills are in poor to defective condition with some environmental staining, spalling and cracks in the sills.

Top to bottom: east elevation (general), east elevation masonry (typical).

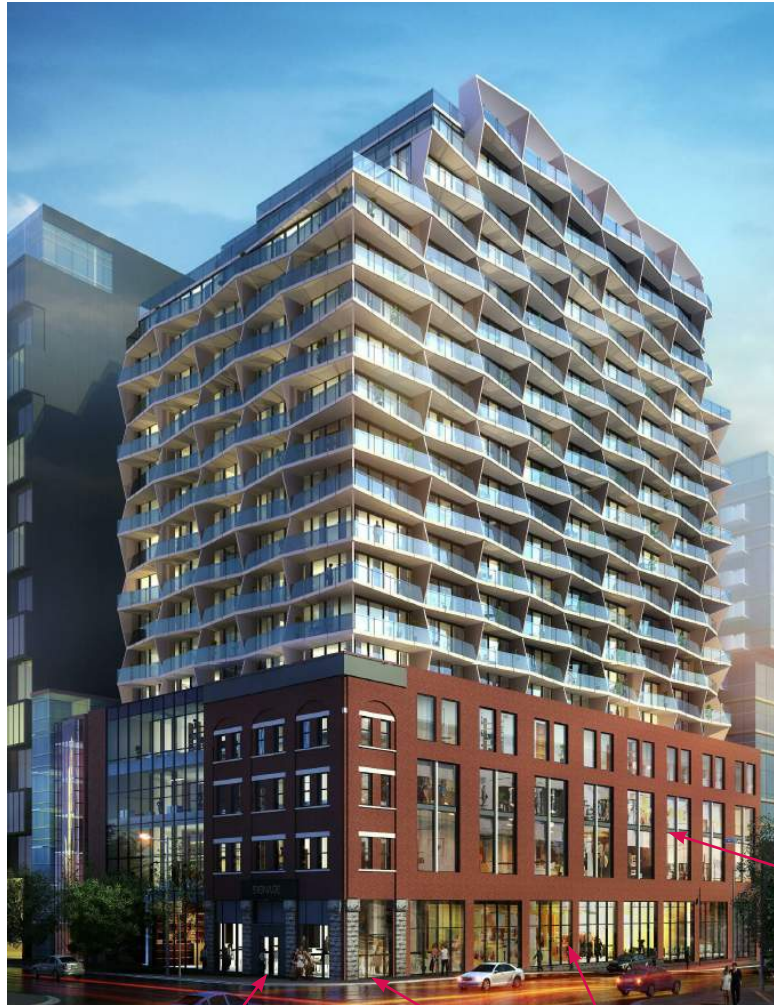
Opening modified for universal accessibility

Lowered ground floor

Building fabric replaced with four-storey red brick podium

- the building at 663 King Street West will be partially retained;
- the retained façade section will be supported with a temporary bracing structure during demolition of the west elevation and construction of the new structure;
- modifications will be made to the floor levels and entrances to accommodate accessibility;
- the new structure will be tied into the retained façade from bottom to top, as it is constructed, providing internal lateral bracing to the façade;
- a conservation scope, to be detailed in a Conservation Plan, will be undertaken for the remaining building fabric; and
- the temporary bracing structure will be removed.

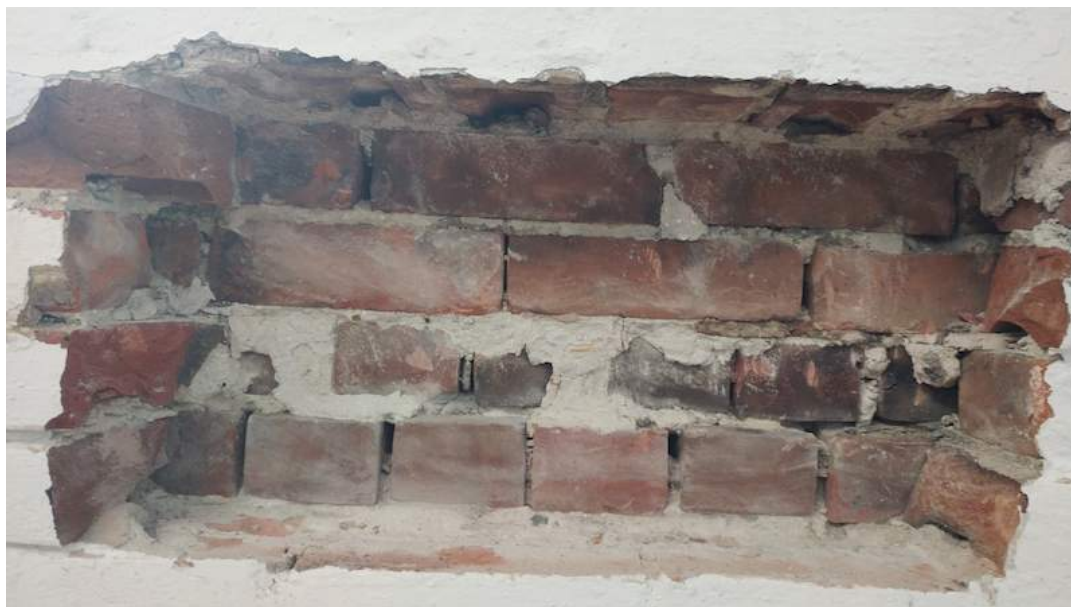
### Location 1 – Bathurst Street South 4<sup>th</sup> Floor

Shown here is the double wythe brick wall with decorative header courses that corbel out on exterior just below the window sill height on the 4<sup>th</sup> floor (South original cornice decorative detail). The headers are bearing on less than the width of a single brick and could be seen as a liability to pedestrian traffic below if work were to be performed on the wall in the future. Noticeable efflorescence and salt migration into the interior coursing is causing the paint to peel and crack.

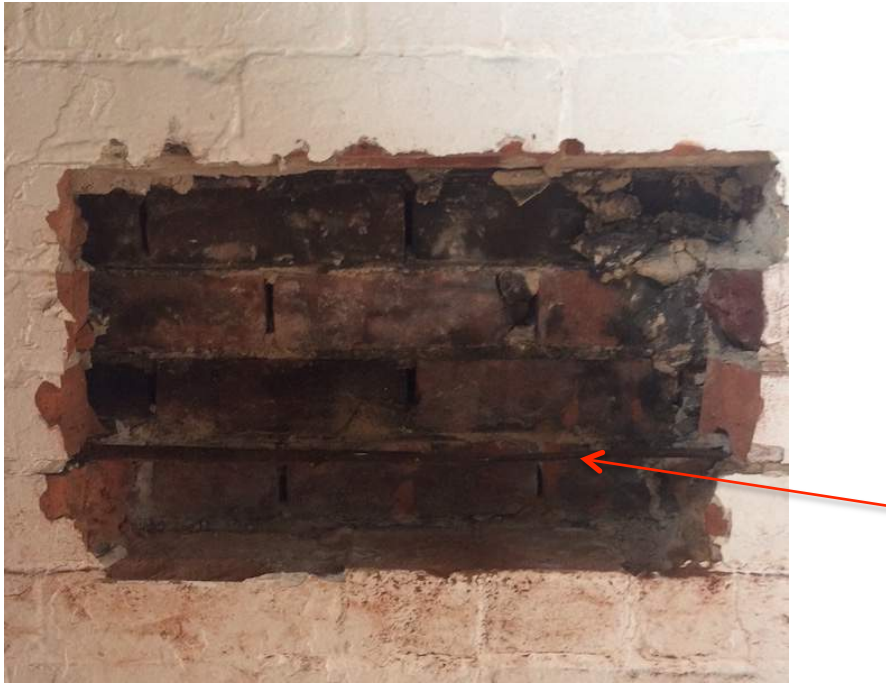
**Location 2 Stewart Street - Just below window sill height**

A hole was made on the Stewart Street side and we noticed the use of steel strapping to help reinforce the double brick wall. This was the only location we found this. All of the openings on the 4<sup>th</sup> floor exhibited the original cement-free lime mortar that was typical of the era. This fourth floor wall section is in poor condition.

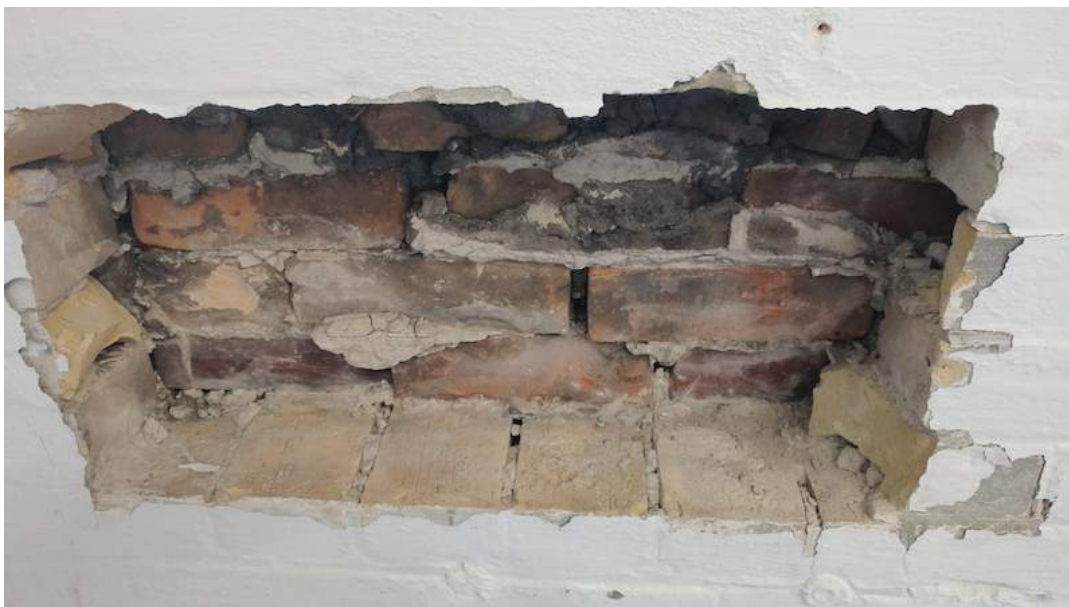
**Location 3 - King Street - Just below window sill height West corner**

Depending on the section of wall we were opening, there was a change in the interior brick from red to buff colour. Shown here is the interior buff row of headers that are tied into the inner red/orange building brick. The center course of brick then ties the exterior wythe together with the use of header courses visible from the exterior. All headers in this photo are showing no signs of cracking. This section was part of an exterior pilaster. Excessive mortar loss is seen on the exterior walls. This fourth floor wall section is in poor condition.

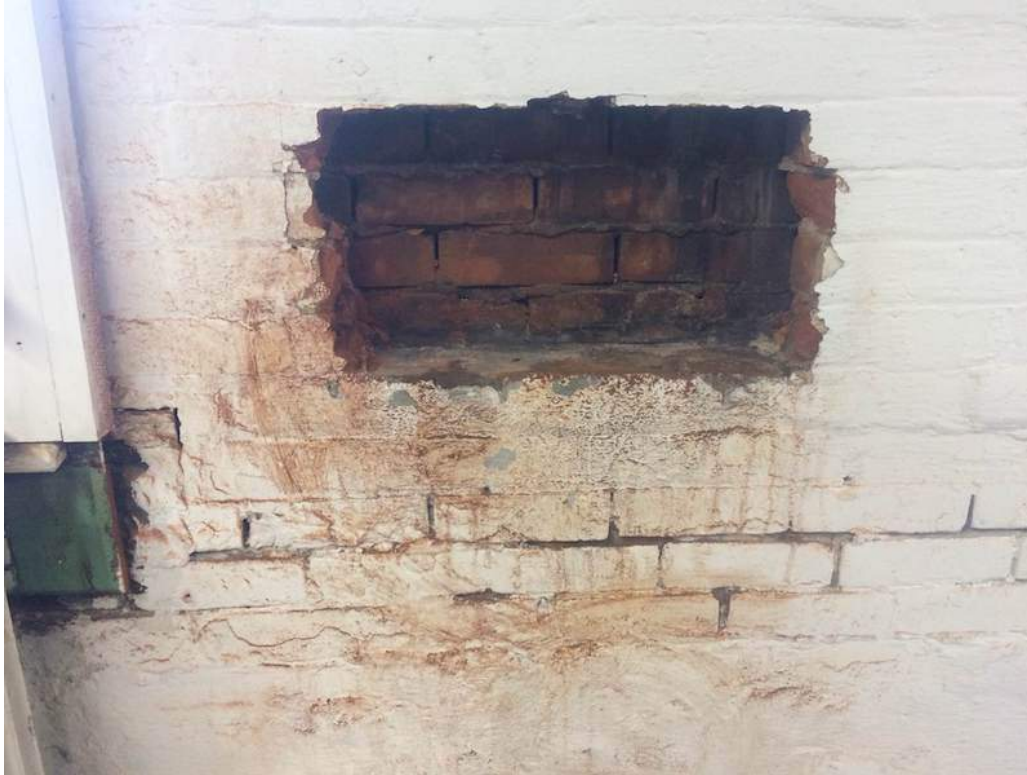
**Location 4 Bathurst Street 4<sup>th</sup> Floor (just above window sill)**

Along the entire 3 feet of the interior 4<sup>th</sup> floor there is cement parging on the interior wall. This is an old repair and has been covered with paint for a long time. The parging was a quick solution to repairing the spalled brick and often covers up worse problems from years of neglect. Cement coatings seal the wall and do not allow for moisture to pass through the brick, causing compounding effects from freeze thaw and salt migration. We noticed this wall to be very unstable during the brick removal, especially near or below the windows. This fourth floor wall section is in poor condition.

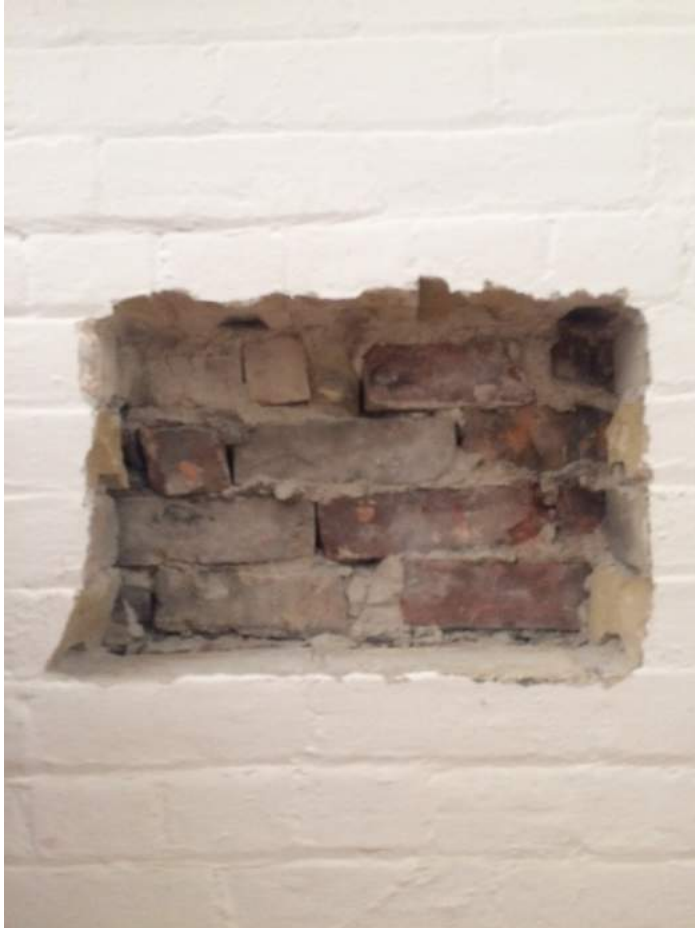
**Location 5 Stewart Street 4<sup>th</sup> Floor South Center location**

A section of the Stewart Street fourth floor south center wall with interior fill coursing. The wall looks to be in good condition and looks to be functioning as it should. Buff Brick was used as interior with a mixture of infill. This building is triple brick wall thickness. It should be noted that the building on the South East corner near Stewart street was built around the same time with similar materials (brick/lime mortar).

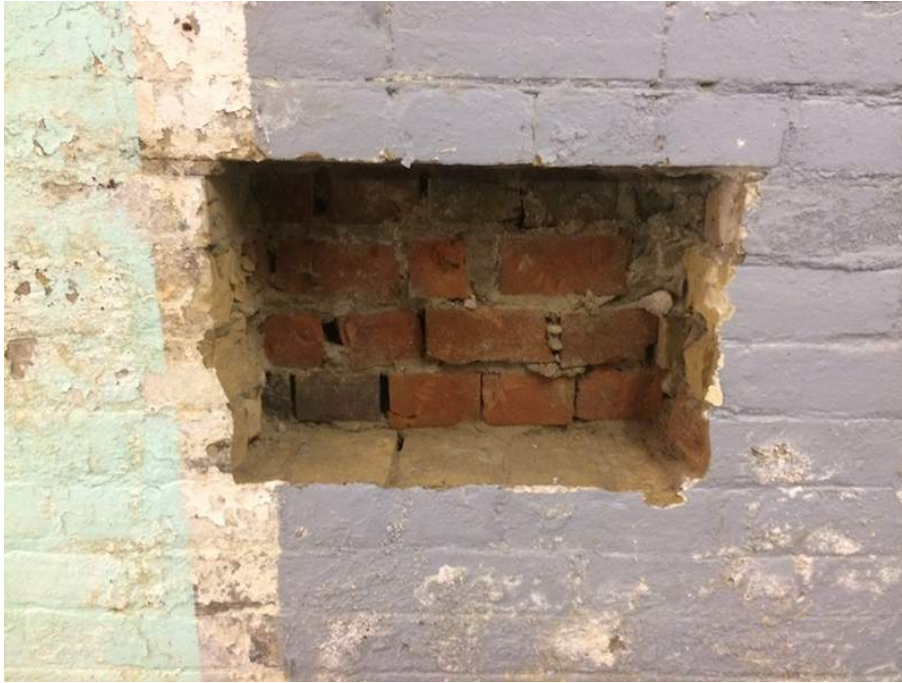
**Location 6 Stewart Street West Corner**

Shown here is the Basement foundation brickwork on the Stewart Street West corner. The wall, we guess, is 18 inches thick, comprising 4 courses of brick. There are salt deposits found just under the paint and typical of a brick foundation. The yellow buff brick was used for its density and durability over the softer red brick. No signs of interior brick spalling or cracking. This fourth floor wall section is in fair condition as the interior brick has very little deterioration.

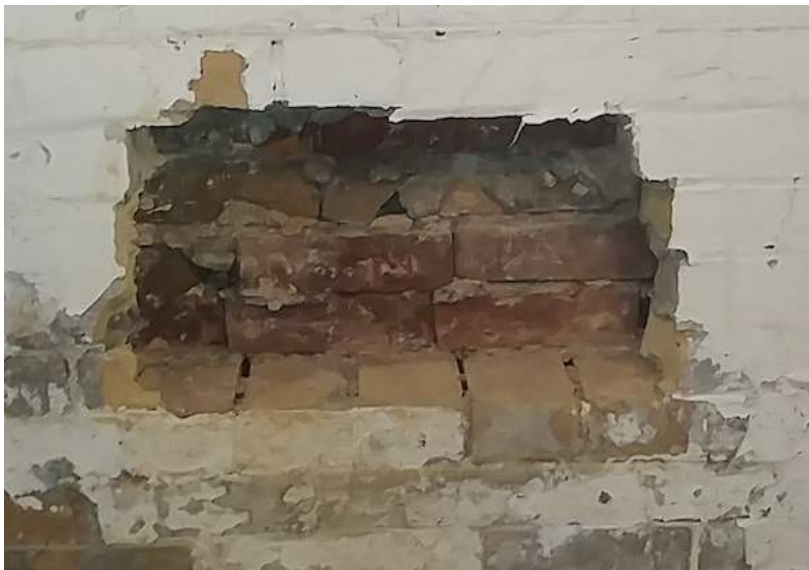
**Location 7 – Hoxton Basement Bathurst side**

This photos shows the interior buff wall to be in fair condition despite the paint and cement parging. The interior brick coursing was loosely and is tied into the exterior brick wall facing Bathurst Street.

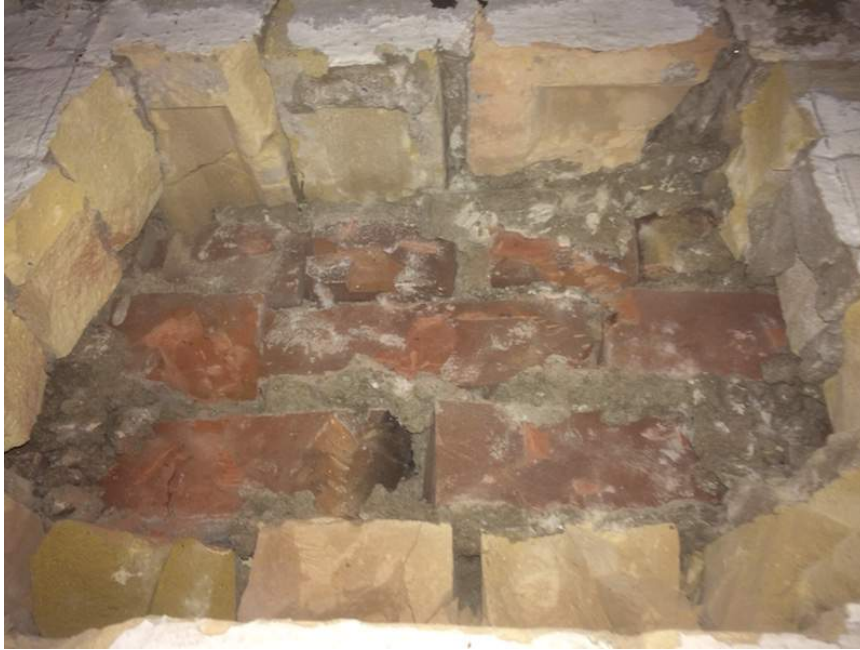
### Location 8 – King Street Basement Brick Foundation

This test hole was completed in the bottom of the Bank Note basement. It is facing the King Street side. The photo shows the harder buff brick tied into the interior wall. The exterior brick wall is most likely the same yellow buff brick. The wall looks to be in good condition.

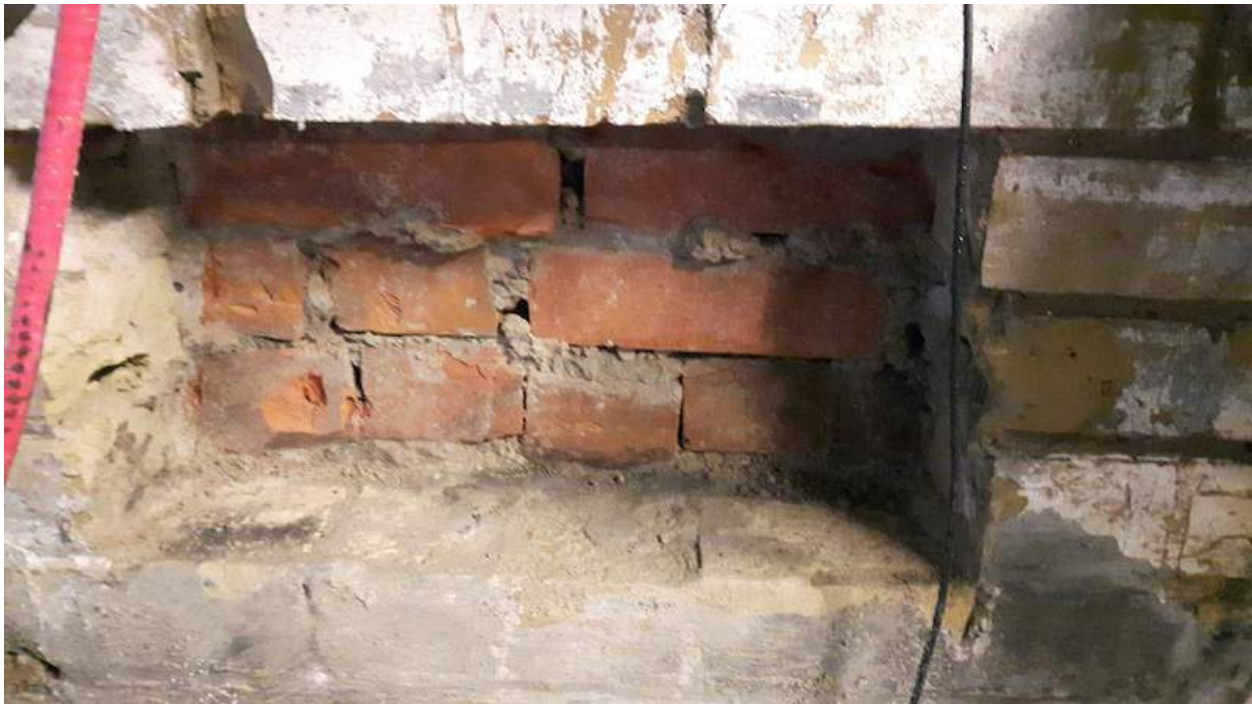
### Location 9 Stewart Street Basement

Another example of the basement foundation brickwork. This section was parged and painted a white back. The interior wall looks to be in fair condition with previous poor repairs and painted surface peeling off. The interior wall looks to be in good condition.
